Manhole Inspection Summary

Manhole # S21M1_005MH

Insp Date: **5/1/08 12:24 PM**

Location Address: **2307 w patapsco av**

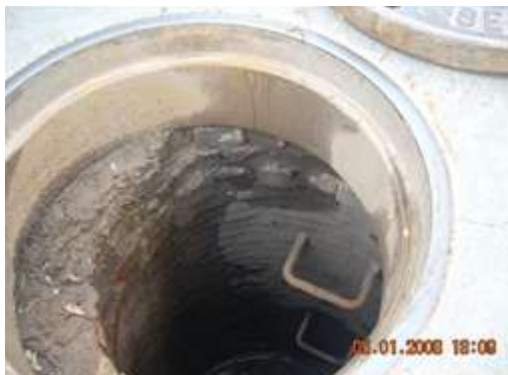
Misc. Defect 2

Subject To Ponding: **Sheeting**

additional view of infiltration. inflow evidence from sheeting

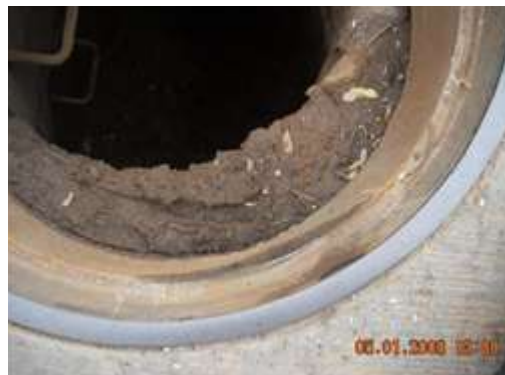
Defect 1

Offset: **4** (in.)

frame offset

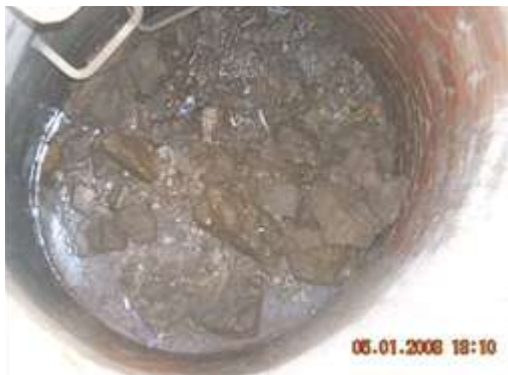
Defect 4

Condition: ☐ Sound ☐ Cracked ☐ Root Intrusion ☐ Deteriorated ☐ Leaks ☒ **Debris**

debris in terminal channel

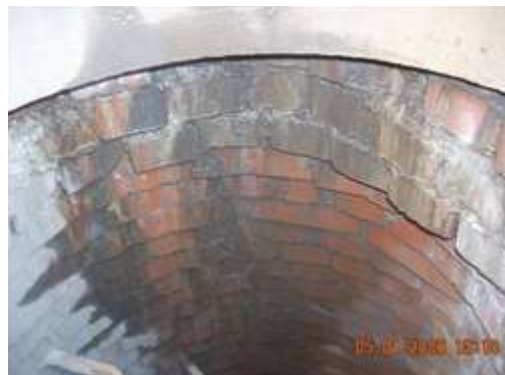
Defect 3

Infiltration: ☐ None ☒ **Joint** ☐ Cracks ☐ Mortar ☐ Roots ☐ Wall

infiltration @ chimney/frame joint

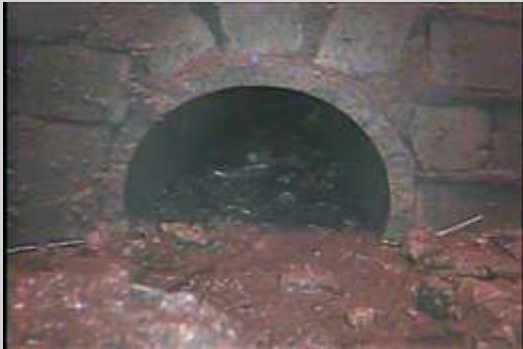
12 O'Clock Outflow

8 in. Circular Gravity Sewer
Pipe Out @ 12 O'Clock

Deposits: ☐ None ☒ **Mud** ☐ Sludge ☐ Debris ☐ Grease

Silt Depth: **3** (in.) Deposits Extent: **Medium**
